October 24, 2016

Re: Geotechnical Engineering Assessment of Dairy Farm Storage Pond Berm  
4207 West Linwood Avenue, Turlock, California  
*SFB Project No.: 727-1*

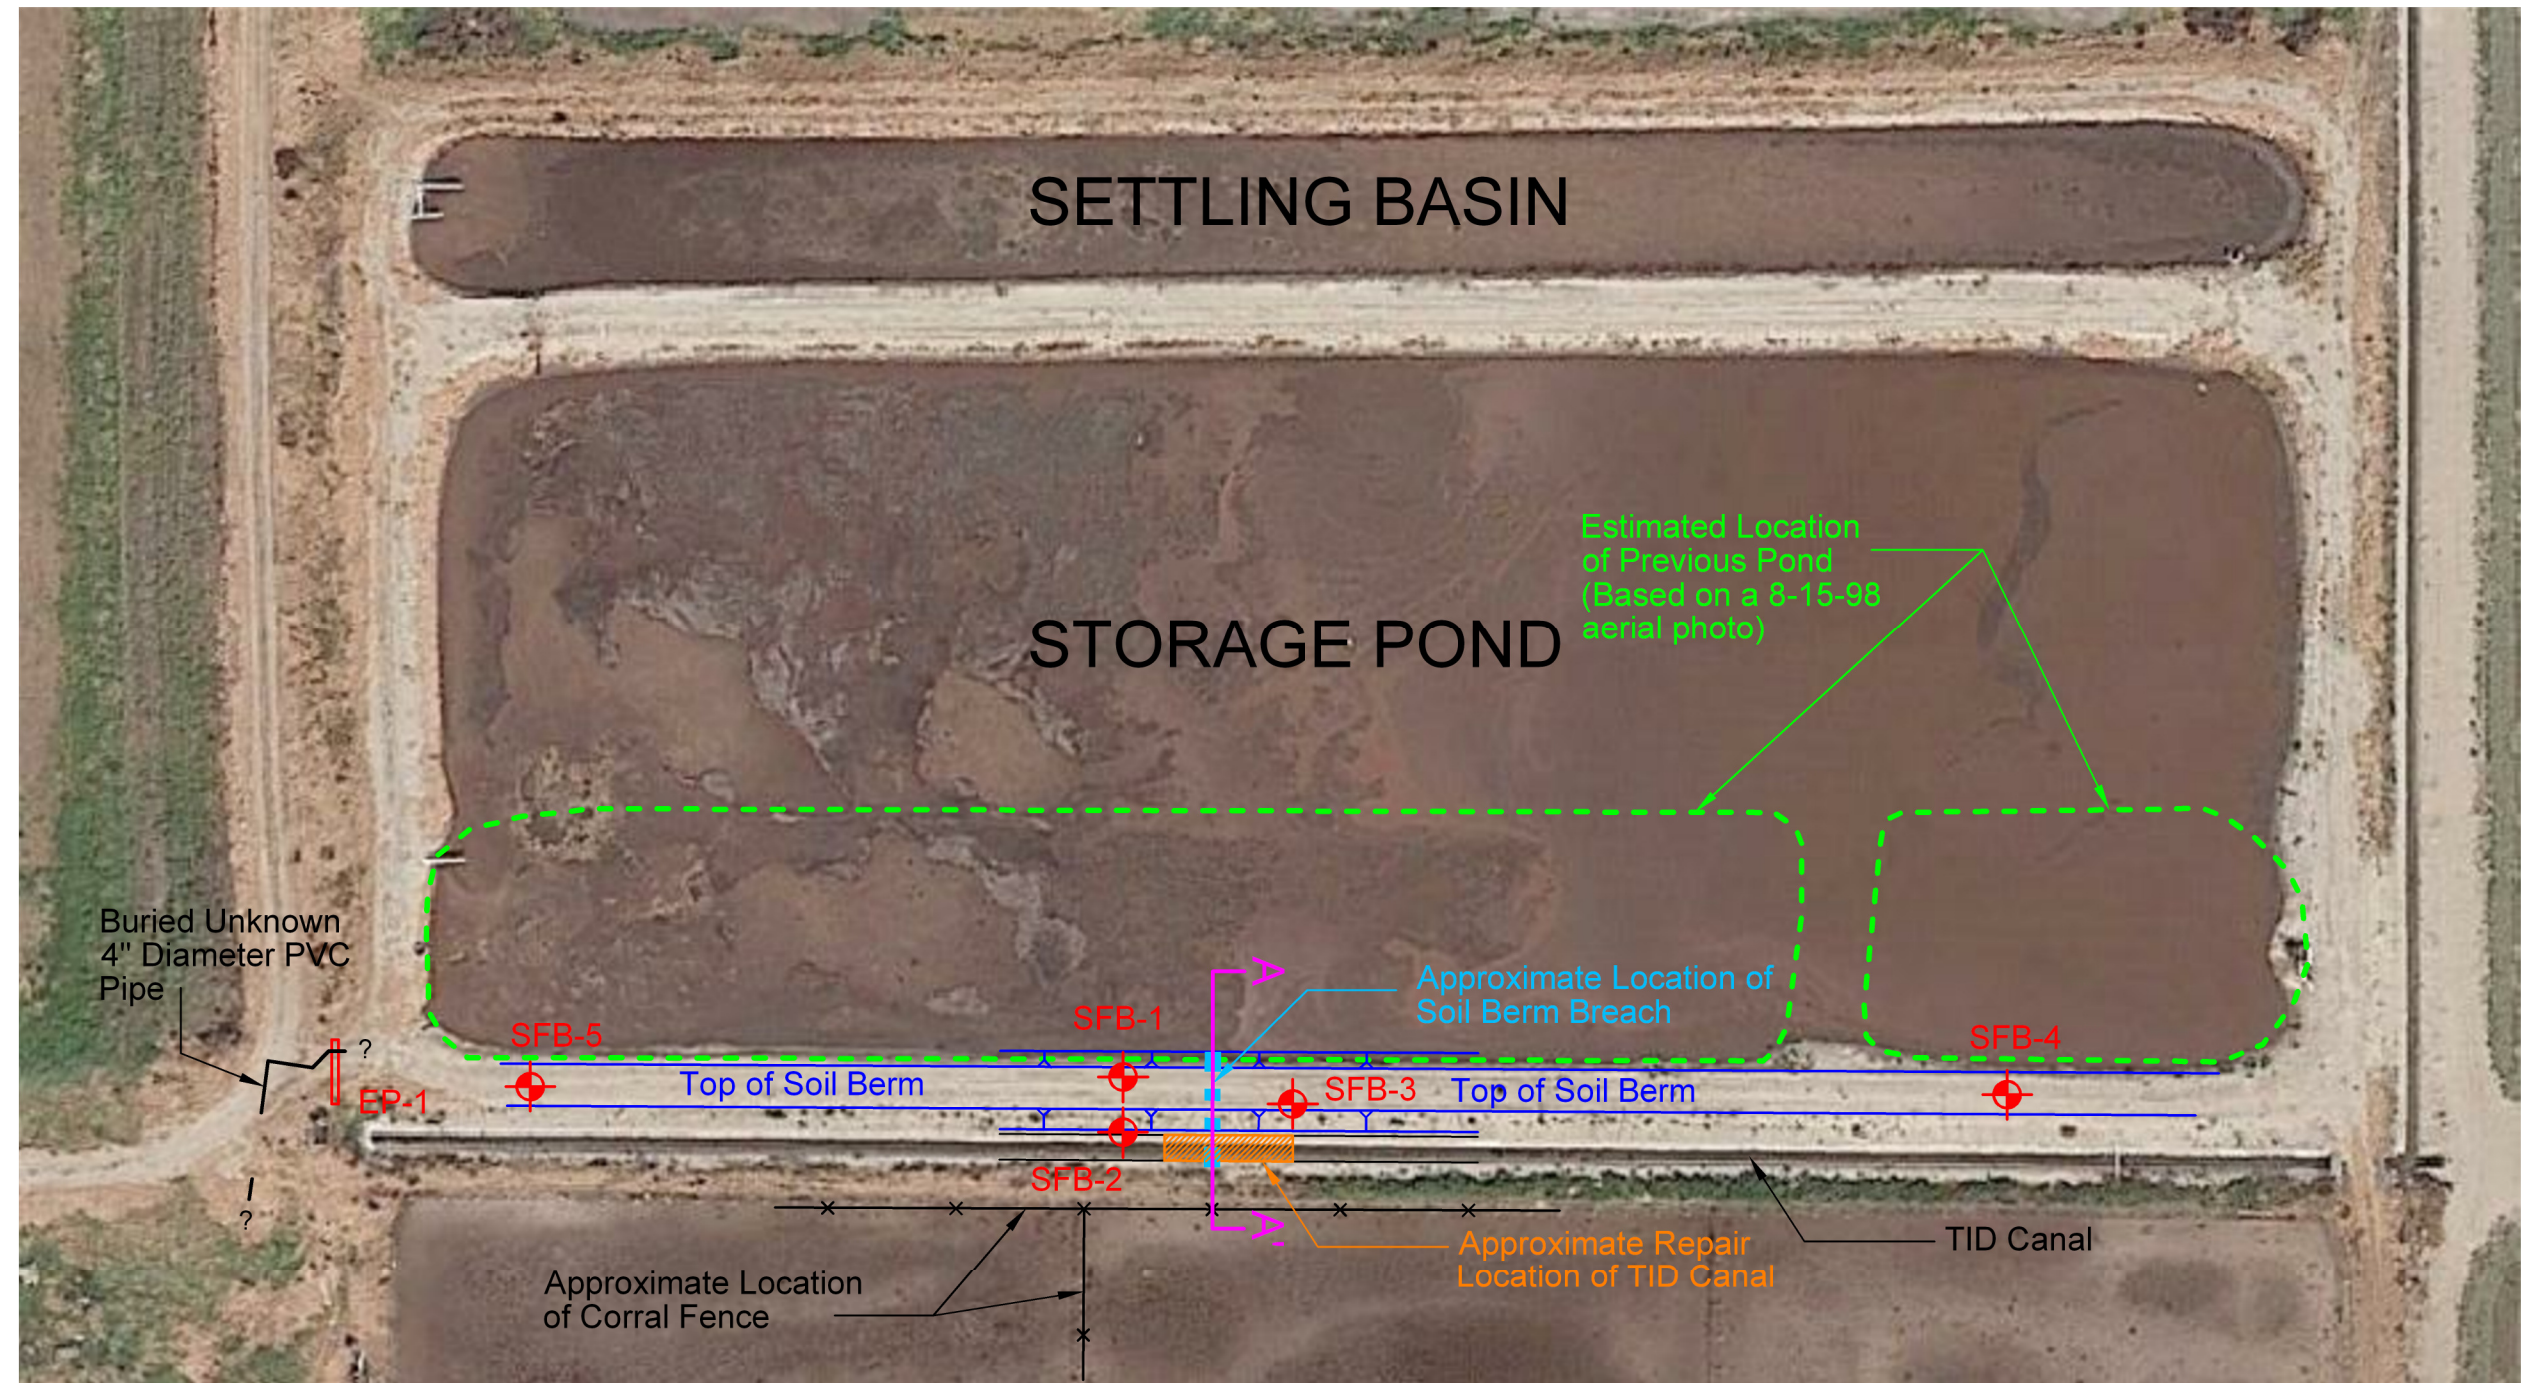
1

It is our understanding that a breach of the southern berm occurred in the morning of November 20, 2015, which resulted in wastewater discharging to the areas south of the storage pond. The approximate location of the breach is shown on Figure 1.

SFB performed reconnaissance of the dairy farm storage pond and surrounding area on May 4, 2016. At the time our reconnaissance, the breach had been repaired and the pond water level was about 3 feet below top of the southern berm. An about 40-foot long section of the TID canal concrete lining had been replaced. Some large and small animal burrows were also observed on the outer face of the southern berm. Cross-Section A – A' (attached as Figure 2) shows the approximate ground profile across the southern berm based on our field measurements and EAC Engineering surveys (attached in Appendix C for reference). All ground features are approximately shown on Figure 2.

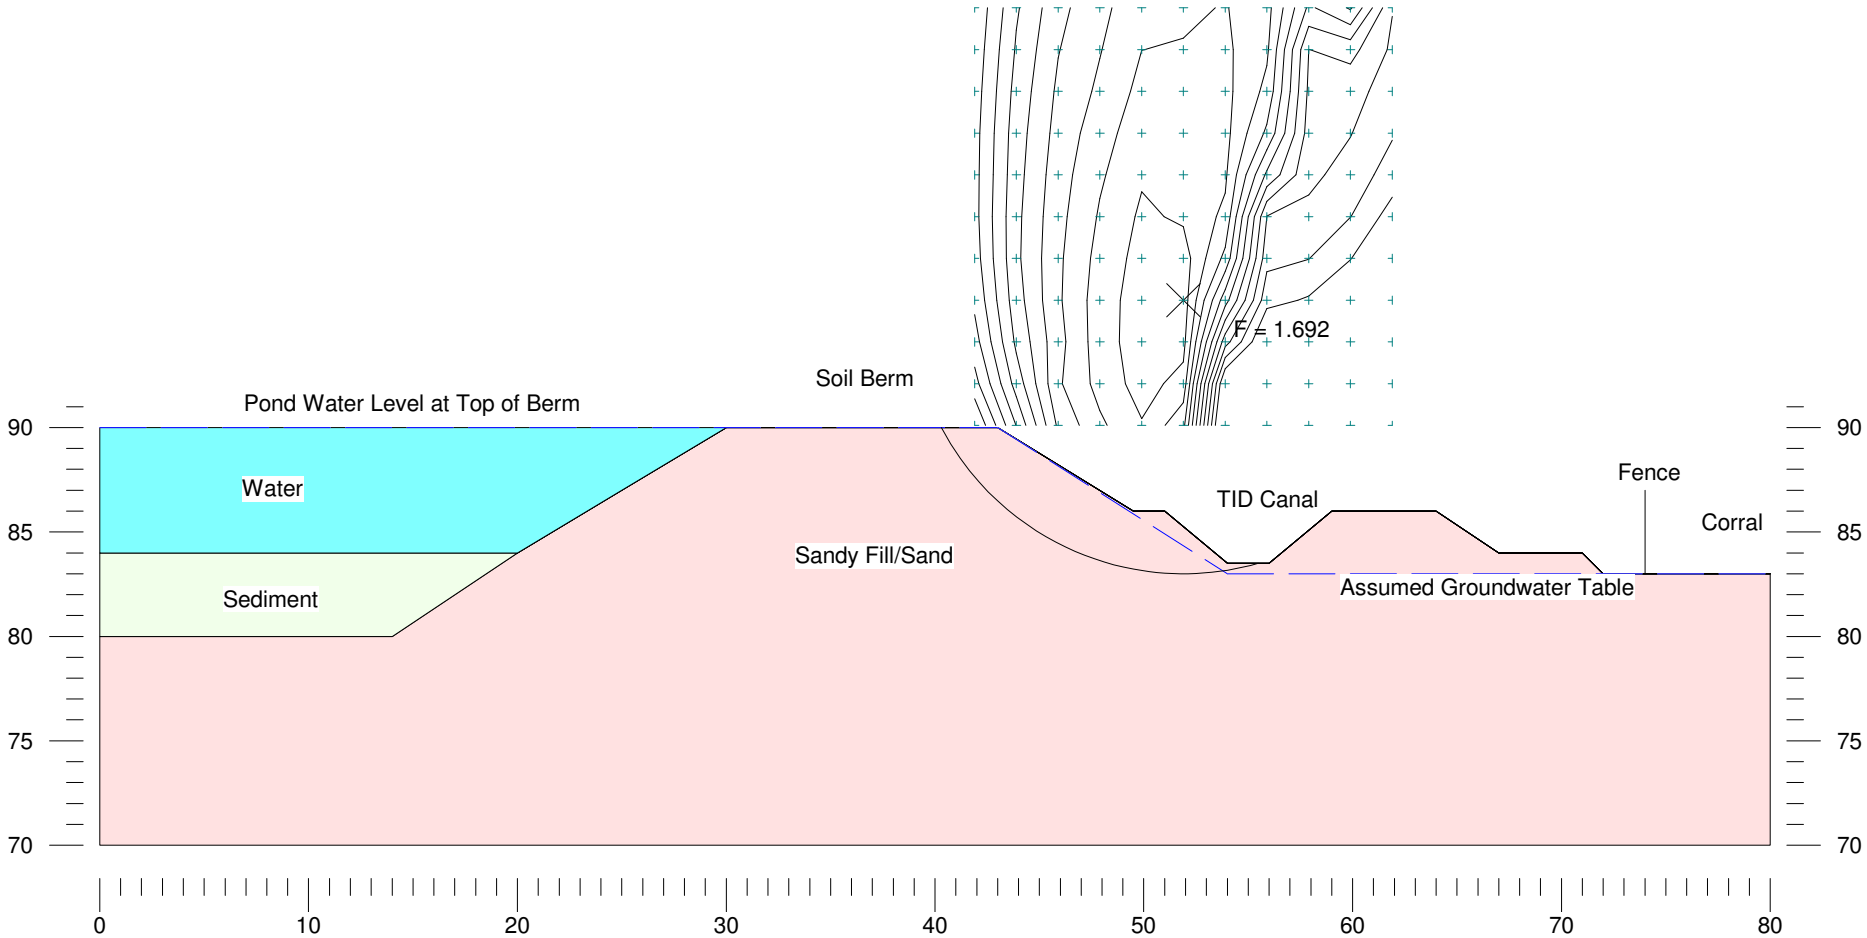
Stevens Ferrone & Bailey Engineering Co. Inc.  
727-1  
Dairy Farm Pond, 4207 West Linwood Ave  
Turlock, CA  
Static  
Case 3: Saturated Soil Berm

The results of our analyses indicate that the factors of safety against sliding under static loading conditions for all cases are greater than the minimum acceptable value of 1.5. In addition, the factor of safety against sliding for Cases 1, 2, 3, and 4 pass the screen criteria outlined in the SCEC publication (factor of safety greater than one) when applying a seismic coefficient of 0.16. Therefore, our slope stability analysis results show that the global and internal stability of the southern berm is acceptable.

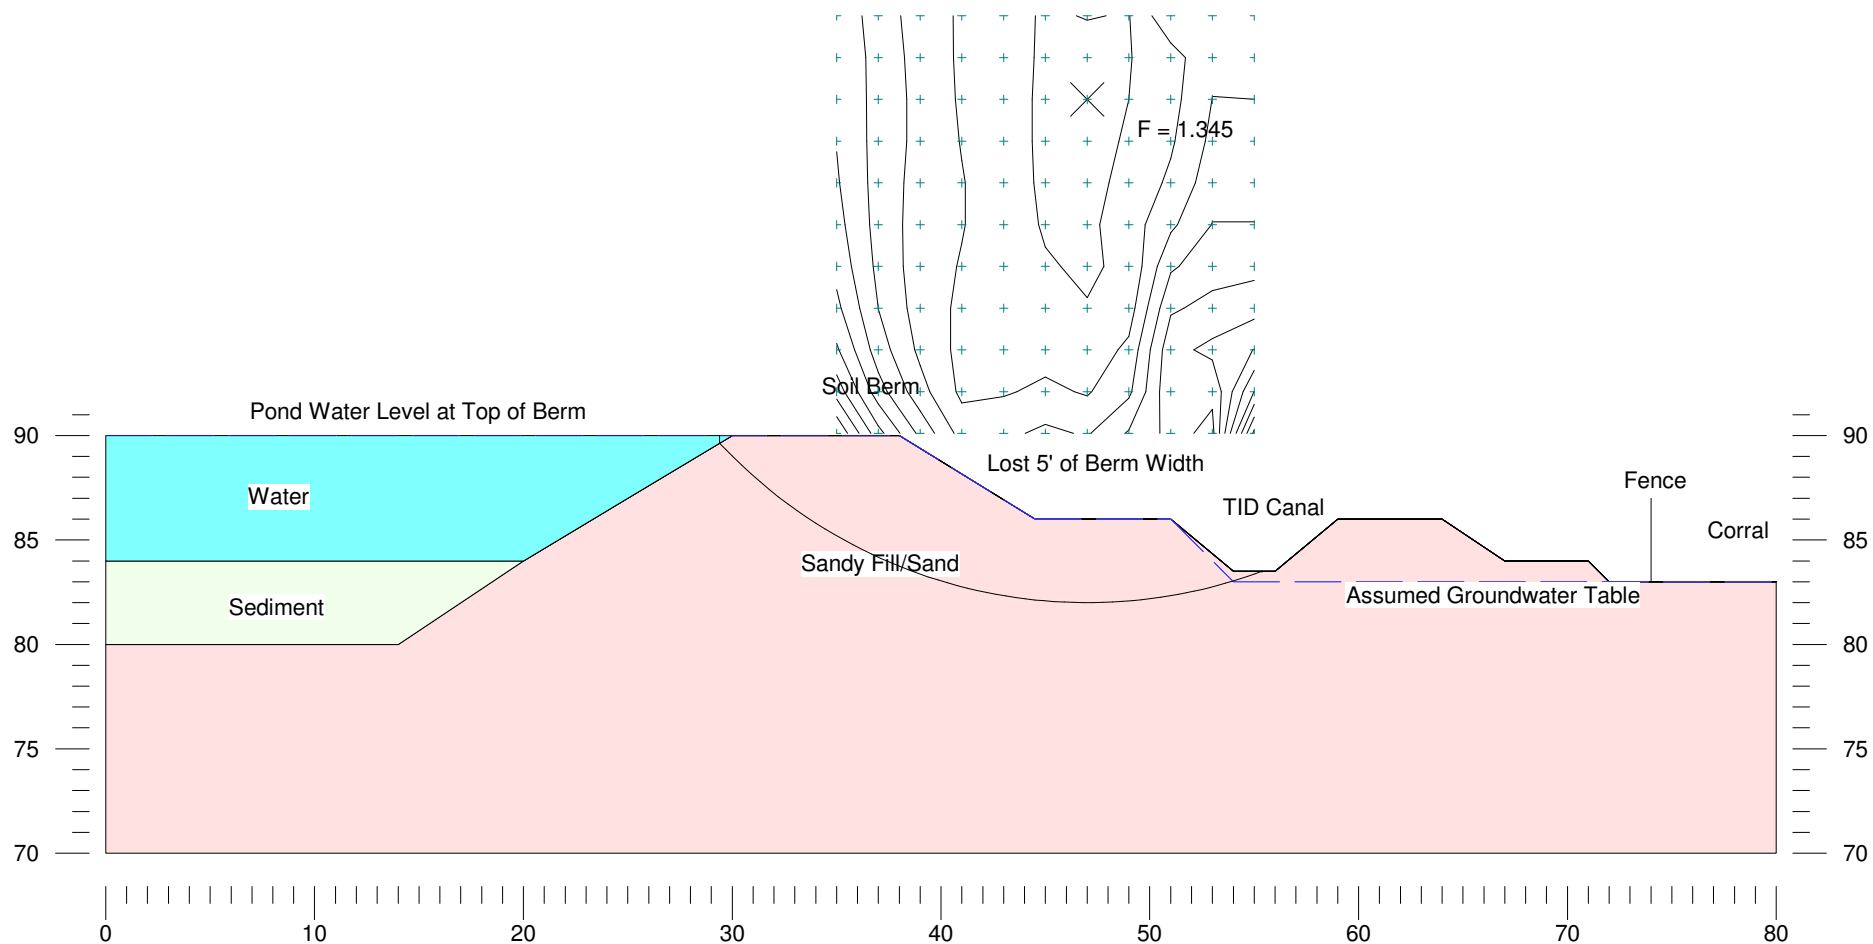
Stevens Ferrone & Bailey Engineering Co. Inc.  
 727-1  
 Dairy Farm Pond, 4207 West Linwood Ave  
 Turlock, CA  
 Pseudo-Static  
 Case 4: Animal Burrow

In addition to the analyzed conditions described previously, we performed a stability analysis of a condition (our Case 4 analyses) where the outer 5 feet of berm is removed under high pond water height (water at the same elevation as the berm) and the berm is saturated. This analysis was performed to account for burrowing animal disturbance along the outboard sides of the berm. The analysis resulted in the static and earthquake factors of safety greater than the minimum requirements of 1.5 and 1.0, respectively. Therefore, this analysis indicates that rodent holes did not, and could not, cause the lagoon berm to fail.

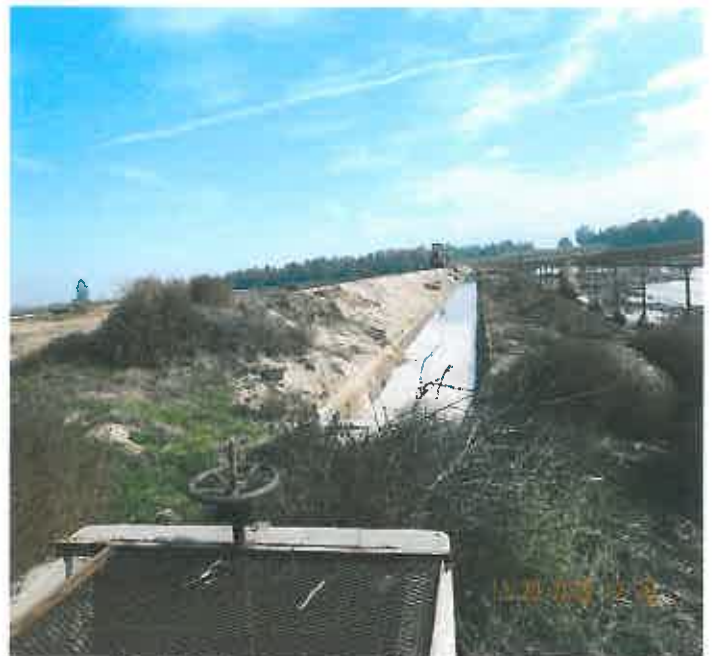
Photo 12: Wastewater in TID canal (south side of the lagoon; west to east view)

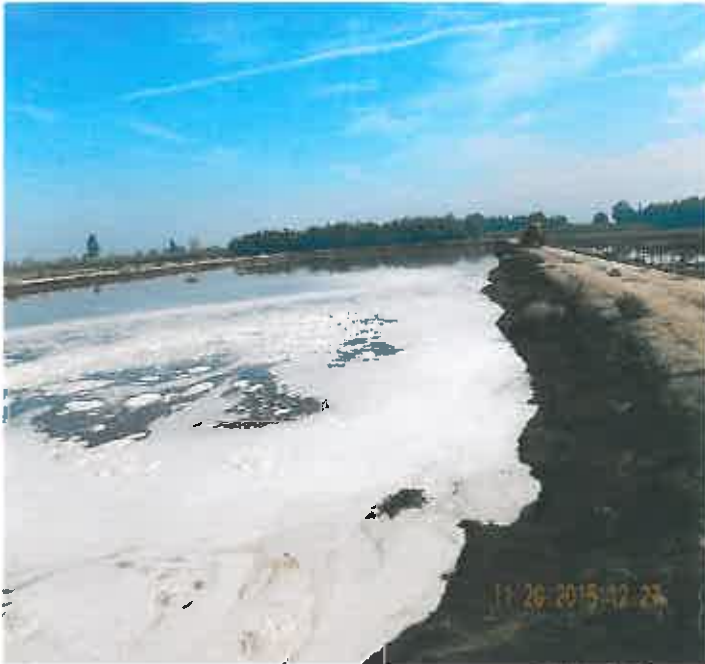
Photo 13: South side lagoon dropped 4 to 5 ft. due to the discharge

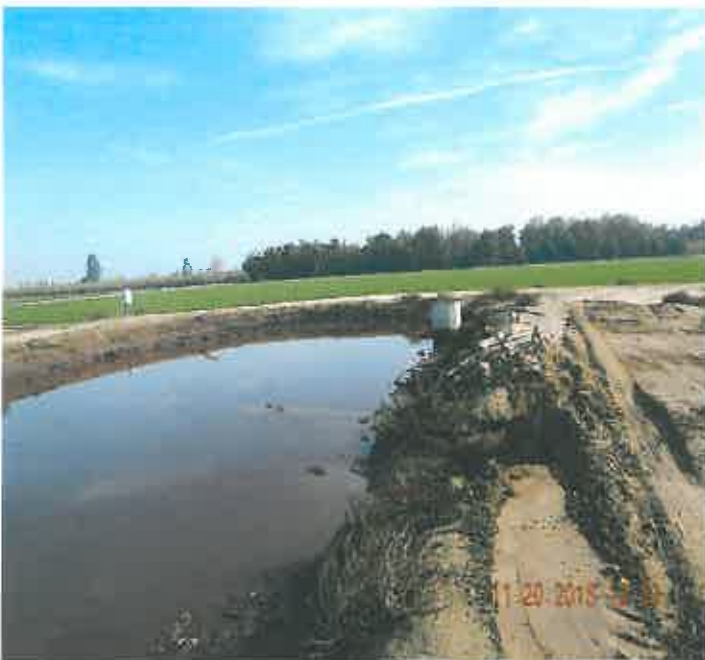
Photo 15: North side lagoon dropped 2-3 ft. due to the discharge

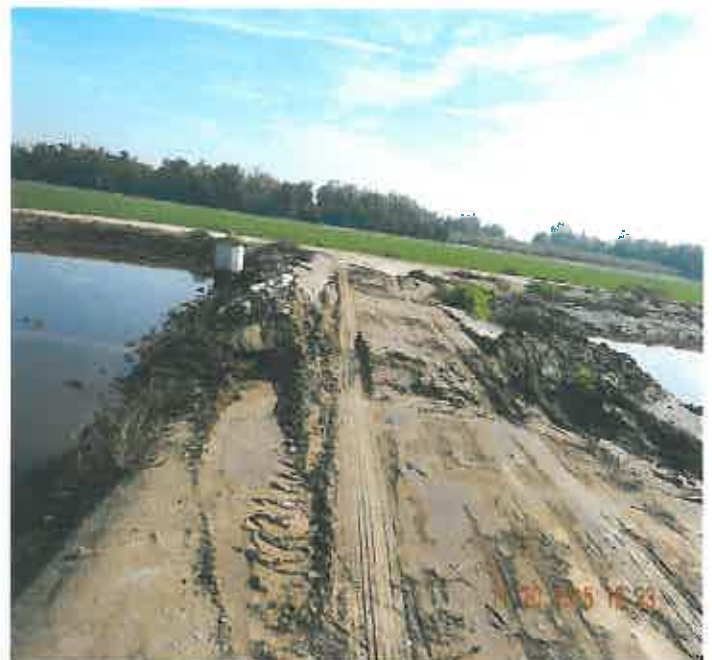
Photo 16: Wastewater from settling basin directed into lagoon by cutting the berm between them

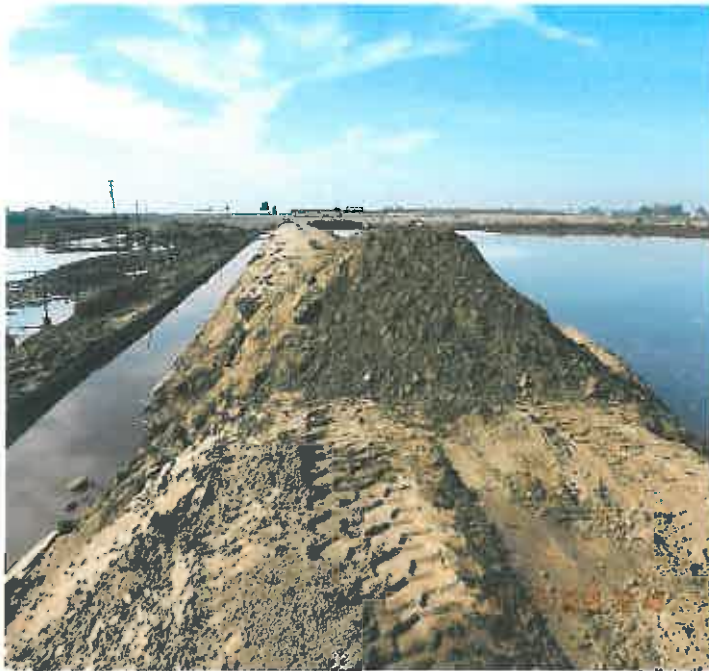
Photo 17 The broken berm of the lagoon being repaired

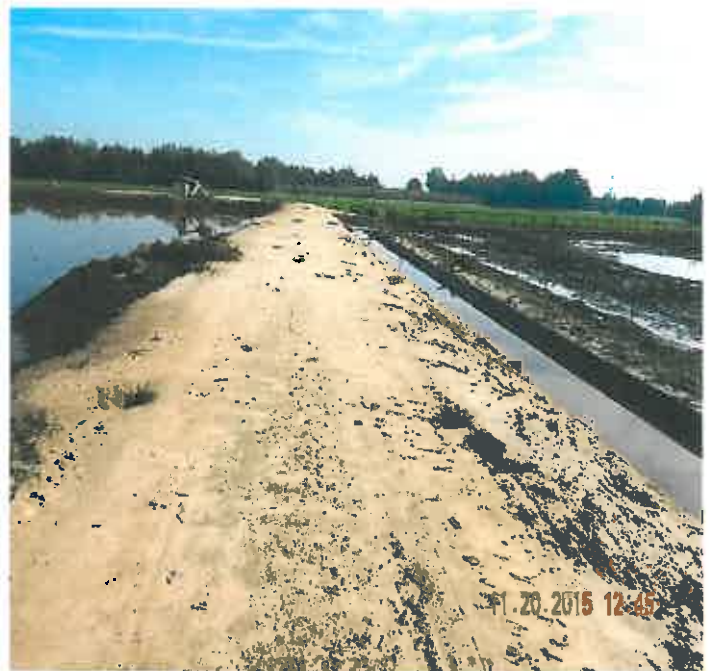
Based on our review of the available documents and field photographs of the breach (see Appendix D for references), the breach appears to be a wash out failure of the berm as a result of water seeping along the interface of a buried pipe. From the photos, we estimate the breach appeared to be about 10 to 15 feet wide with nearly vertical side walls and extended toward the concrete lined TID canal. We did not observe any evidence that the breach extended below the canal. The exact cause of the breach was unknown at the time of the failure. It is also our understanding that a 4-inch diameter PVC pipe (unknown to the property owner) and an electrical conduit (that extends to an existing pump located near the southeastern corner of the pond, and was also unknown to the property owner) were observed within the breached berm section (the 4-inch diameter PVC pipe shown in the field photographs at the time of the breach). A portion of the 4-inch diameter PVC pipe extended toward the inboard face of the storage pond. It should be noted that in a few of the photos of the breach (copies of the reference photos are attached in the back of Appendix D) and as noted in the complaint, a small sinkhole is observed on the top of the berm; the sinkhole formed as a result of the loss of conduit pipe backfill during the formation of the breach. Other sinkholes likely formed on the ground surface directly above and in the vicinity of the breach and immediately prior to the complete breach of the berm. It should be noted that due to the sandy soils within the berm, the sinkholes would have formed no more than a few hours (and more likely, a few minutes) prior to the complete breach of the berm. The sinkholes would have similar visual characteristics as rodent burrows.

Photo 18: Lagoon berm with holes:

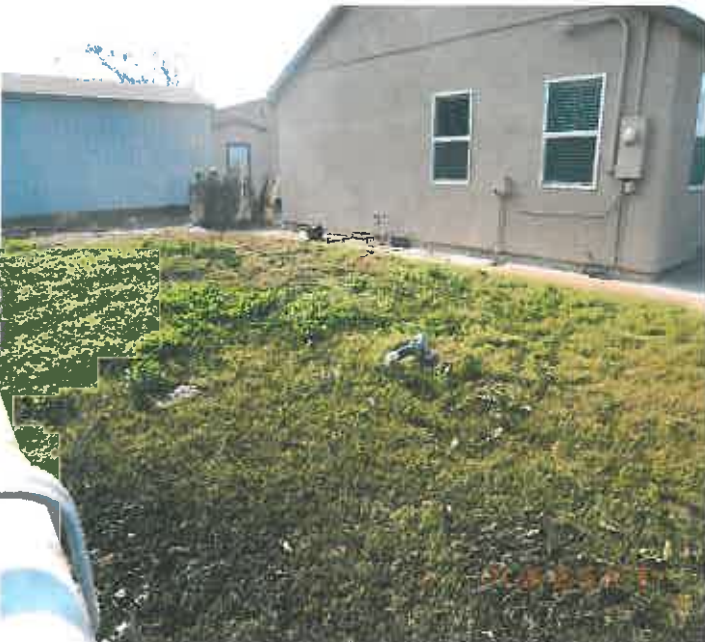
Photo 23: Wastewater reached groundwater well location

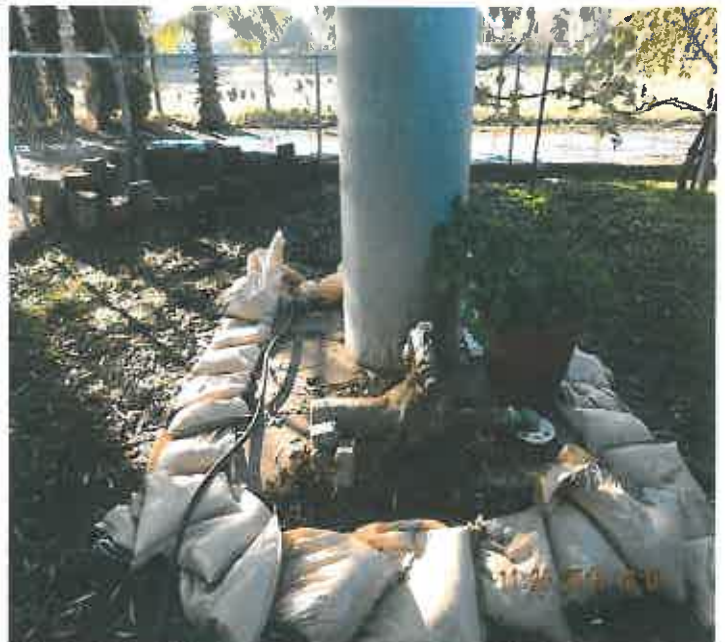
Photo 24: Wastewater reached wells in residential area

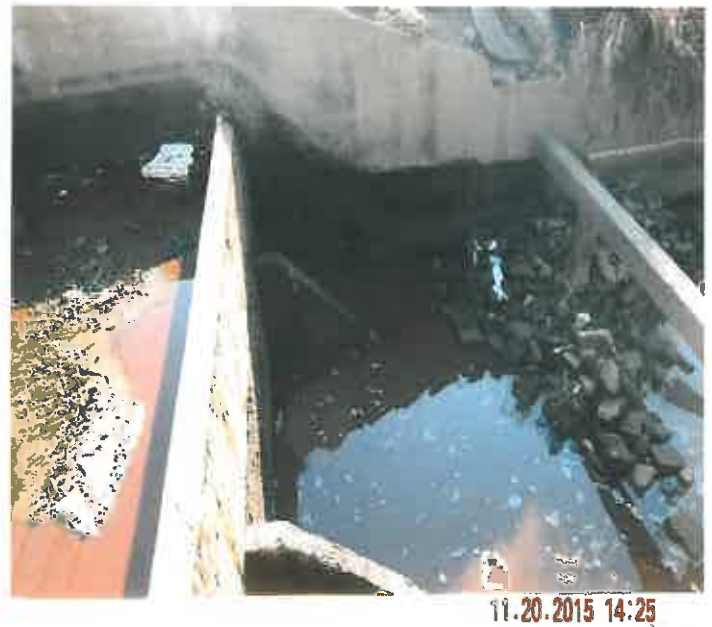
Photo 26: Wastewater leaked into Harding Drain
